CONSTRUCTORA VARGAS NICARAGUA

Building Inspection Rancho Santana – Rivas Nicaragua

Client: Brooks Wilson
Evaluator: Jimmy Ricardo Vargas
Date : Friday, June 24 - 2016

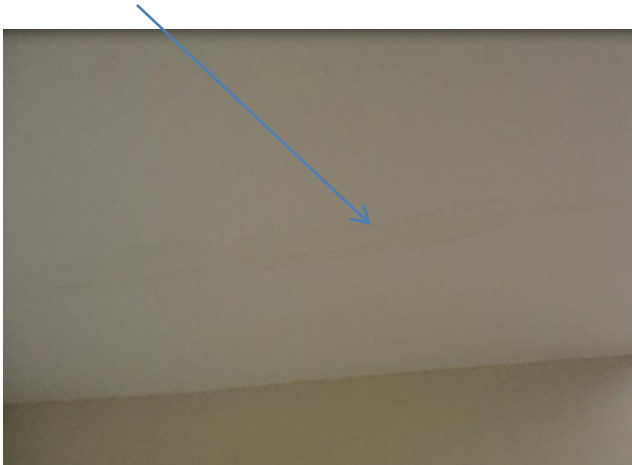
Leak / bedroom

The recommended work in the property is the roof total replacement, remove the tiles and zinc panels, check if the roof structure is well distributed, determine the type of material and the current condition on it, placing new zinc panels of top quality, properly painted with anticorrosive and protected with special material, placing gutters, downspouts, ridgepoles and other necessary elements to work roofs, placing new tiles with other construction characteristics, in the part of the roof where is being used plastic zinc, to give the new construction an inclination to prevent accumulation of water on the surface, also to change the plastic transparent panels by new zinc of polycarbonate material, using a sealant of long lasting and life, to replace the fachaletas on the walls and to place new fachaletas or special decorated bricks according customer preferences, ensuring the new placement of the facade elements, proper fixation and proper procedure, ensuring one larger life expectancy, to avoid that the heat and humidity can come again to destroy the joint of the elements, a new cap in the ceiling hole will be build to guarantee the future maintenance and repairs activities.

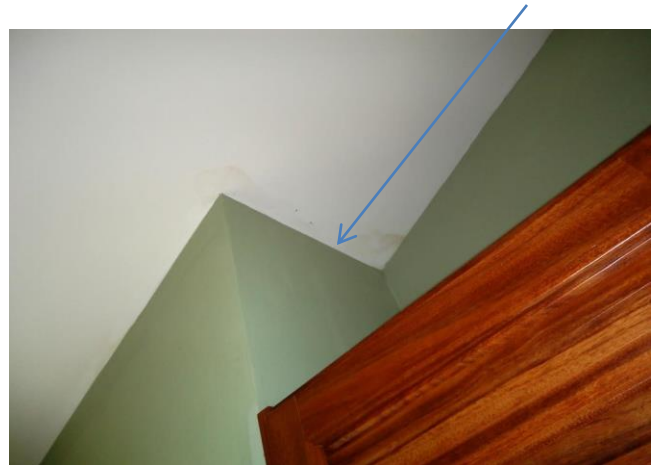
Leak / bedroom

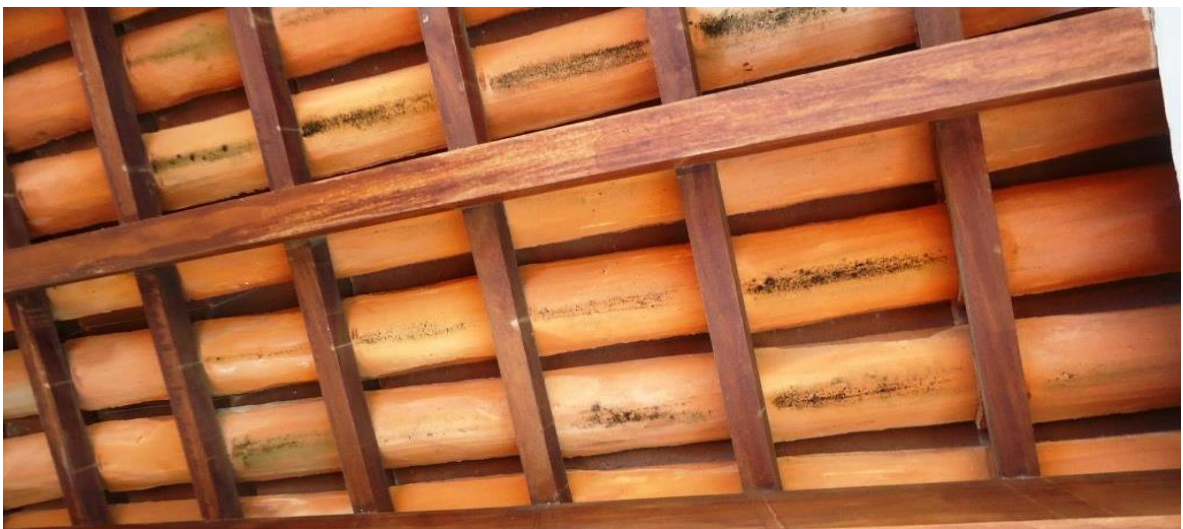
Tiles / Swimming pool

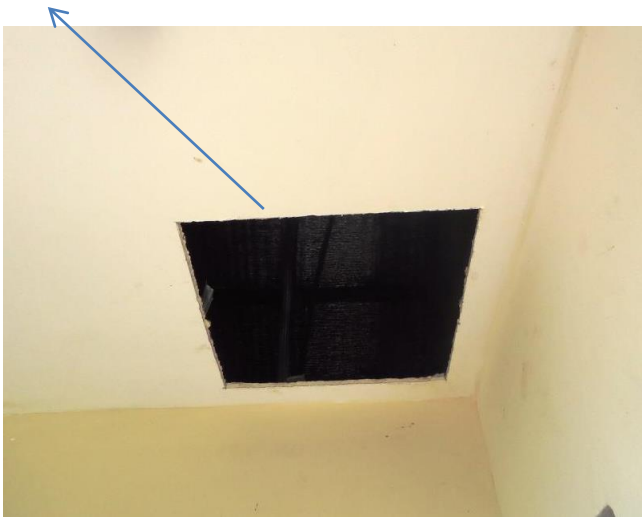
Top space / Ceiling

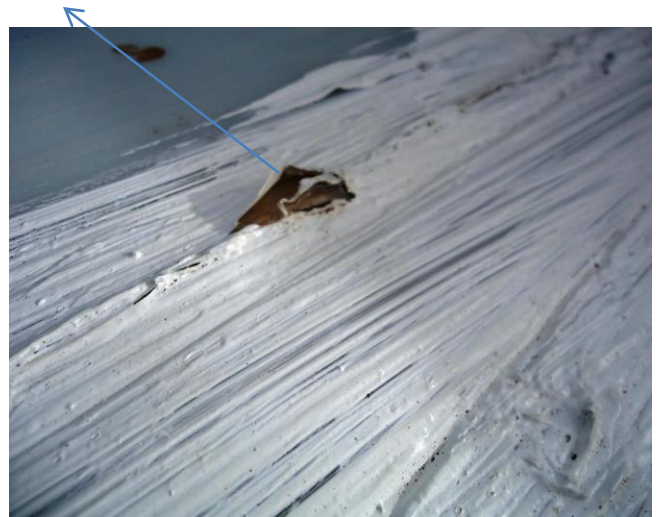
Damaged leak sealer

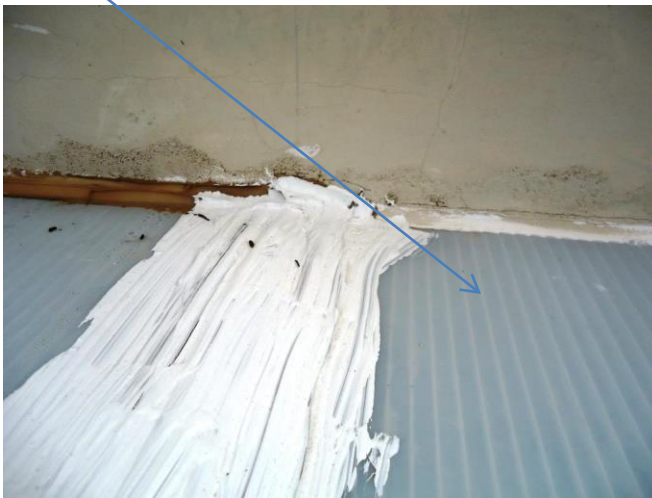
Plastic zinc

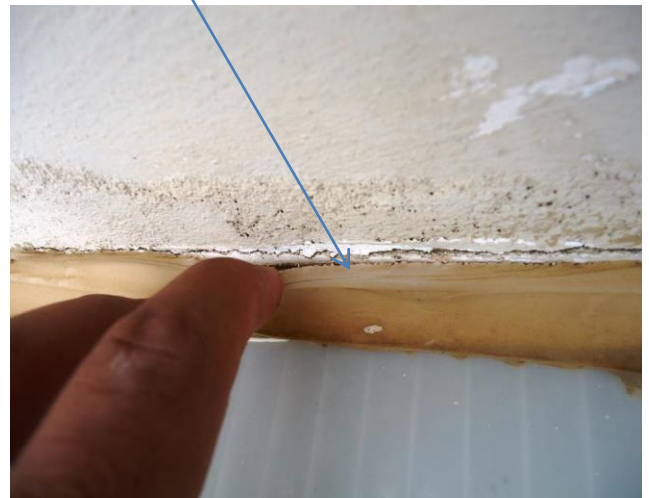
Silicon / not properly fixed

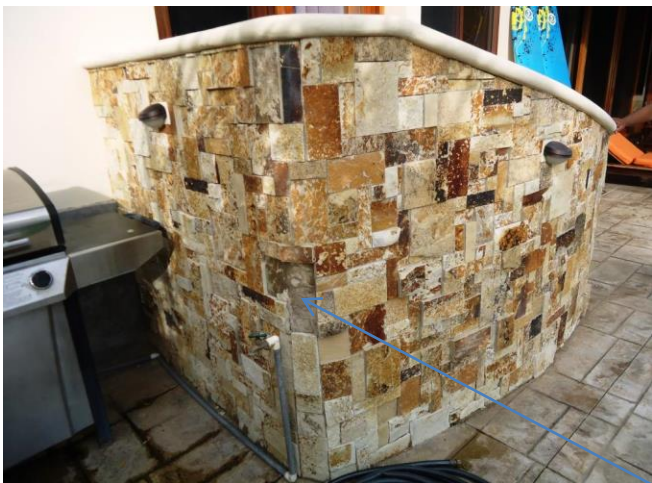
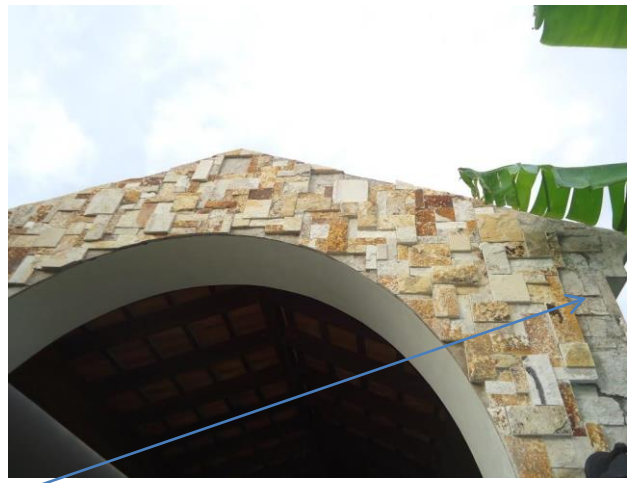
Fachaletas / fallen

Check the structure, condition and type of materials used in the current construction, home owned of Brooks Wilson, photographic survey and taking notes, propose to do one roof total replacement, to change the old bricks used in the home façade, elaboration of cover in the ceiling.
